Manhole Inspection Summary

Manhole # S41UU_013MH

Insp Date: **9/3/08 2:52 PM**

Location Address: **MONTPELIER ST**

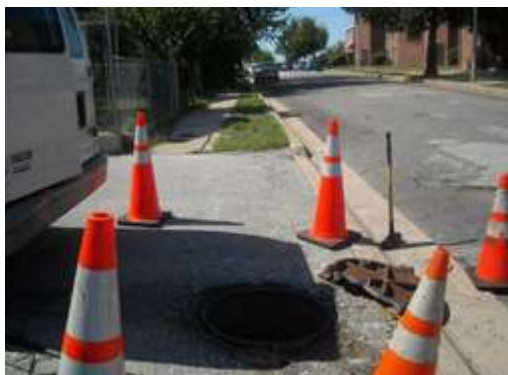
Location View

Comments **DETERIORATED ASPHALT AROUND MANHOLE (see photos); BROKE & REPLACED COVER TO COMPLETE INSPECTION (see photos)**

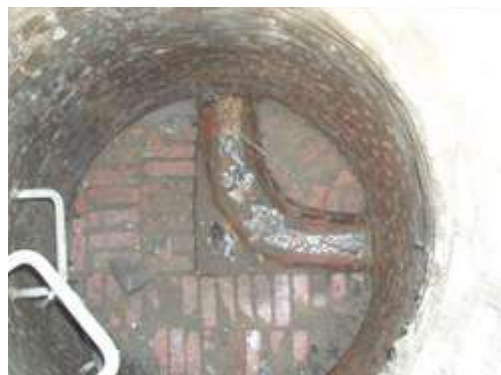
Top View

Evidence of surcharge - Bench debris.

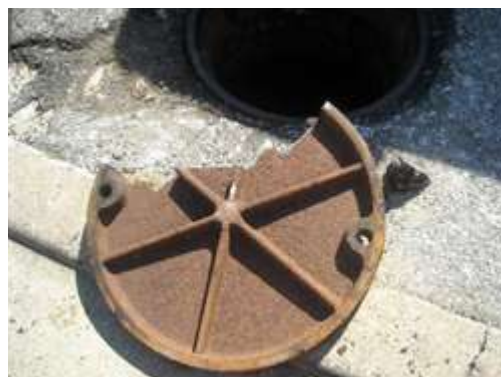
Broken lid

Broke the lid to gain access.

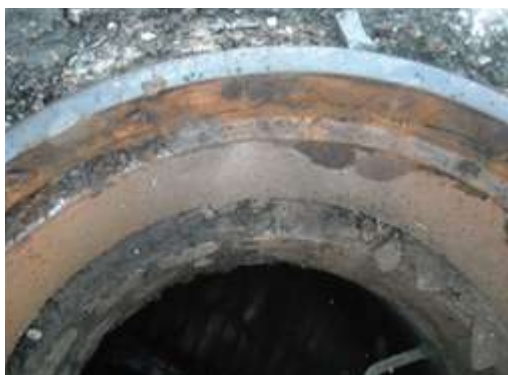
Defect

Frame Offset: **1.5** (in.) Condition: ☐ Sound ☐ Cracked ☒ **Leaks**

Chimney / Frame Adjustment ☒ Exists Material: **Brick** ☐ Parged Height: **2** (in.)
Condition: ☐ Sound ☐ Cracked ☐ Root Intrusion ☒ **Loose Brick** ☒ **Deteriorated**
Infiltration: ☐ None ☒ **Joint** ☐ Cracks ☐ Mortar ☐ Roots ☐ Wall

Frame leaks. Frame offset. Adjustment deterioration and infiltration.

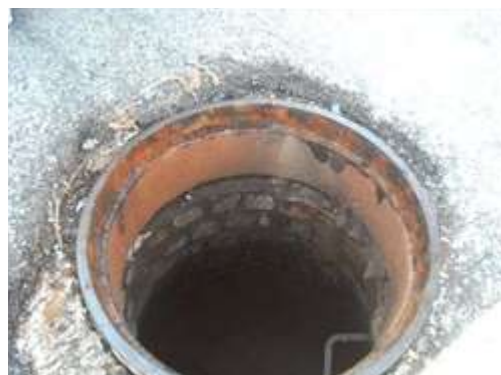
Defect

Frame leaks. Adjustment deterioration, loose brick and infiltration. Corbel infiltration.

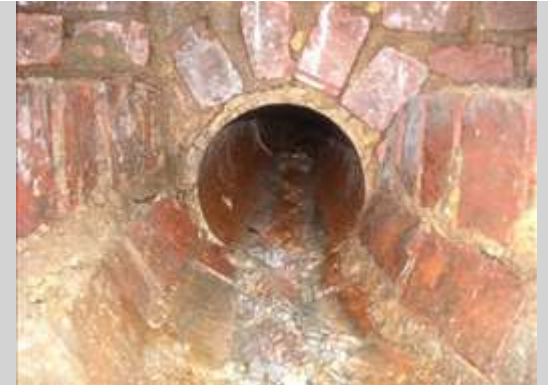
8 in. Circular Gravity Sewer Pipe Out @ 12 O'Clock

Pipe Material: **Clay** ☐ Pipe Lined

Invert Depth: **7.20** (ft.) Flow Characteristics: **Slow**

Infiltration: **None** Pipe Seal Cond: **Unknown**

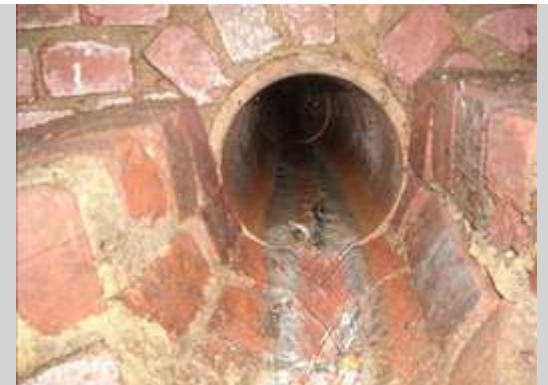
8 in. Circular Gravity Sewer Pipe In @ 3 O'Clock

Pipe Material: **Clay** ☐ Pipe Lined

Invert Depth: **6.75** (ft.) Flow Characteristics: **Slow**

Infiltration: **None** Pipe Seal Cond: **Unknown**
